# Benthic Monitoring Report 2010 Deenish Fish farm

For Marine Harvest Ireland  
by Environmental Services at the Institute of Aquaculture

**BENTHIC MONITORING REPORT 2010: DEENISH FISH FARM**

Issued February 2011

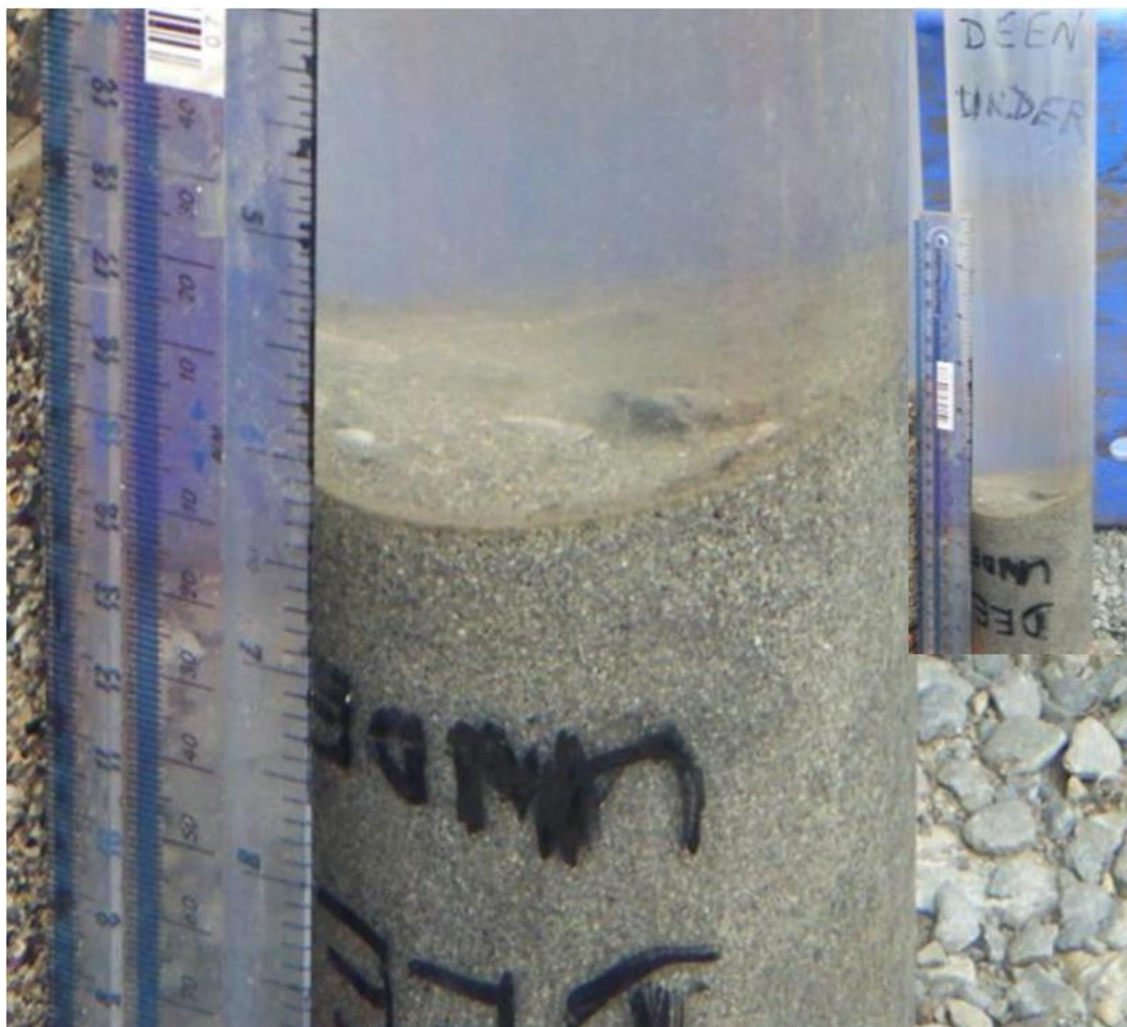
**Figure 2:** Core sample from Deenish fish farm site, taken from under the cages.

The core sample from underneath the cages (Figure 2) was a mix of medium sand. On the sample surface fine particulate material is in evidence, though no distinct feed and faecal material can be seen. The fine layer of material on the sediment surface (Figure 2) is also replicated in the other core samples taken from the site, but not at the control station and is therefore thought likely to result from fish farming activity, through the settlement of waste faecal material. There does not, however, appear to be a build up

of such sediment. There was no discolouration of the sediment (say through bacterial activity, and conversion of iron to ferrous oxide) through any depth.

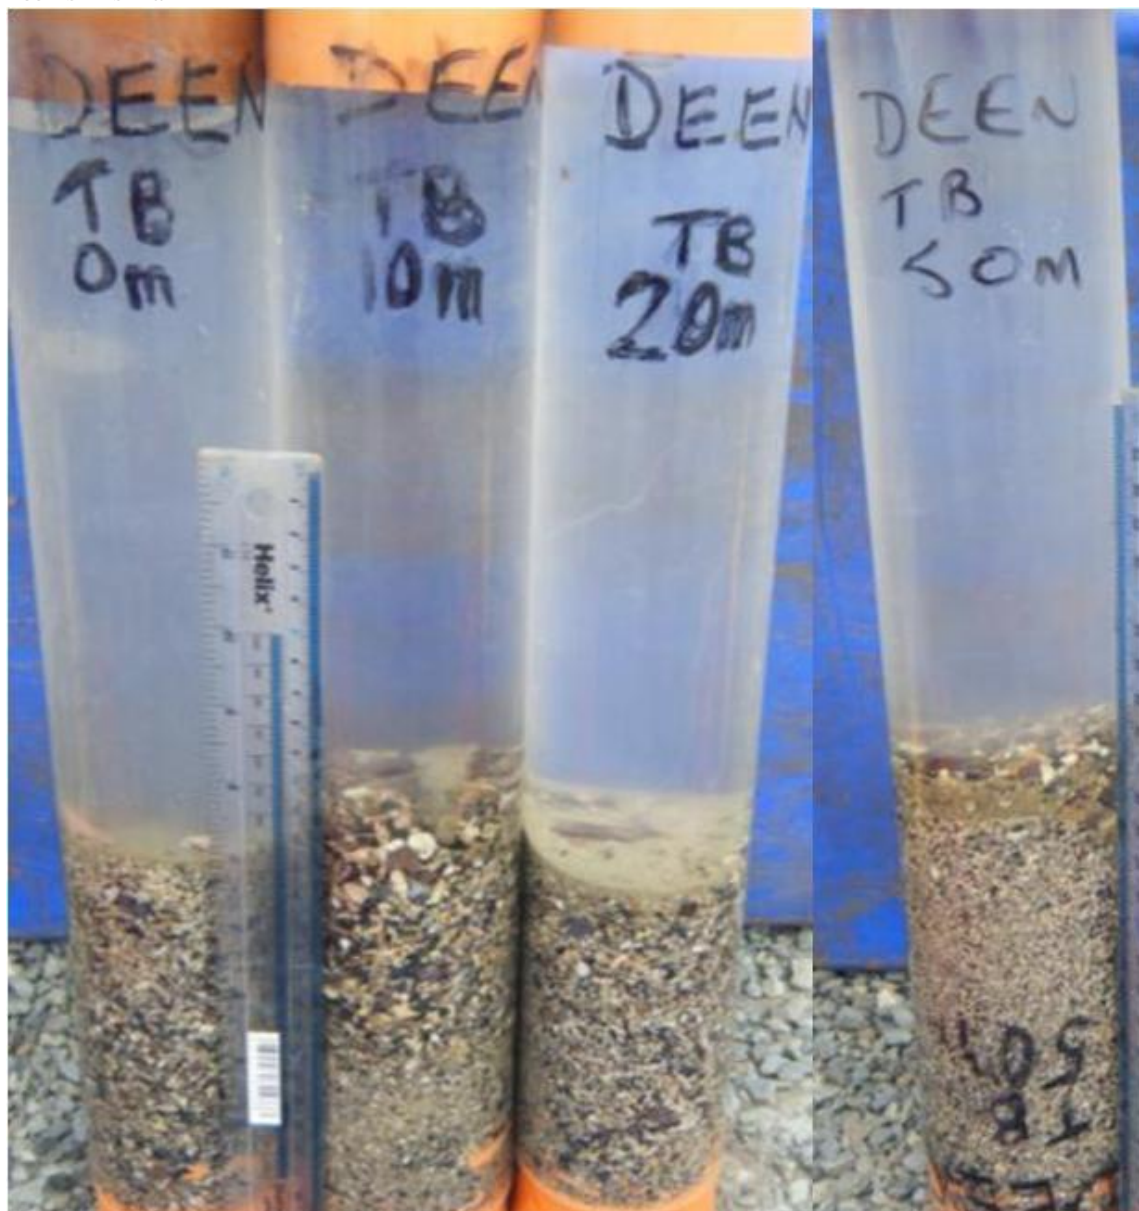
**Figure 4:** Core samples from Deenish fish farm site taken along Transect B at 0m, 10m, 20m, and 50m from cage edge.

The majority of the core samples collected along transect B (Figure 4) are coarse to very coarse sand, consisting of shell fragments and fine gravel. Unlike transect A samples there is no apparent change in grain size with increased distance from the cage site. The look and character of the sediment was very much as described above, with the same thin layer of fine sediment, perhaps 2-3mm thick, over the sediment surface out to TB20m, though this is less visible in the sample at TB50m.

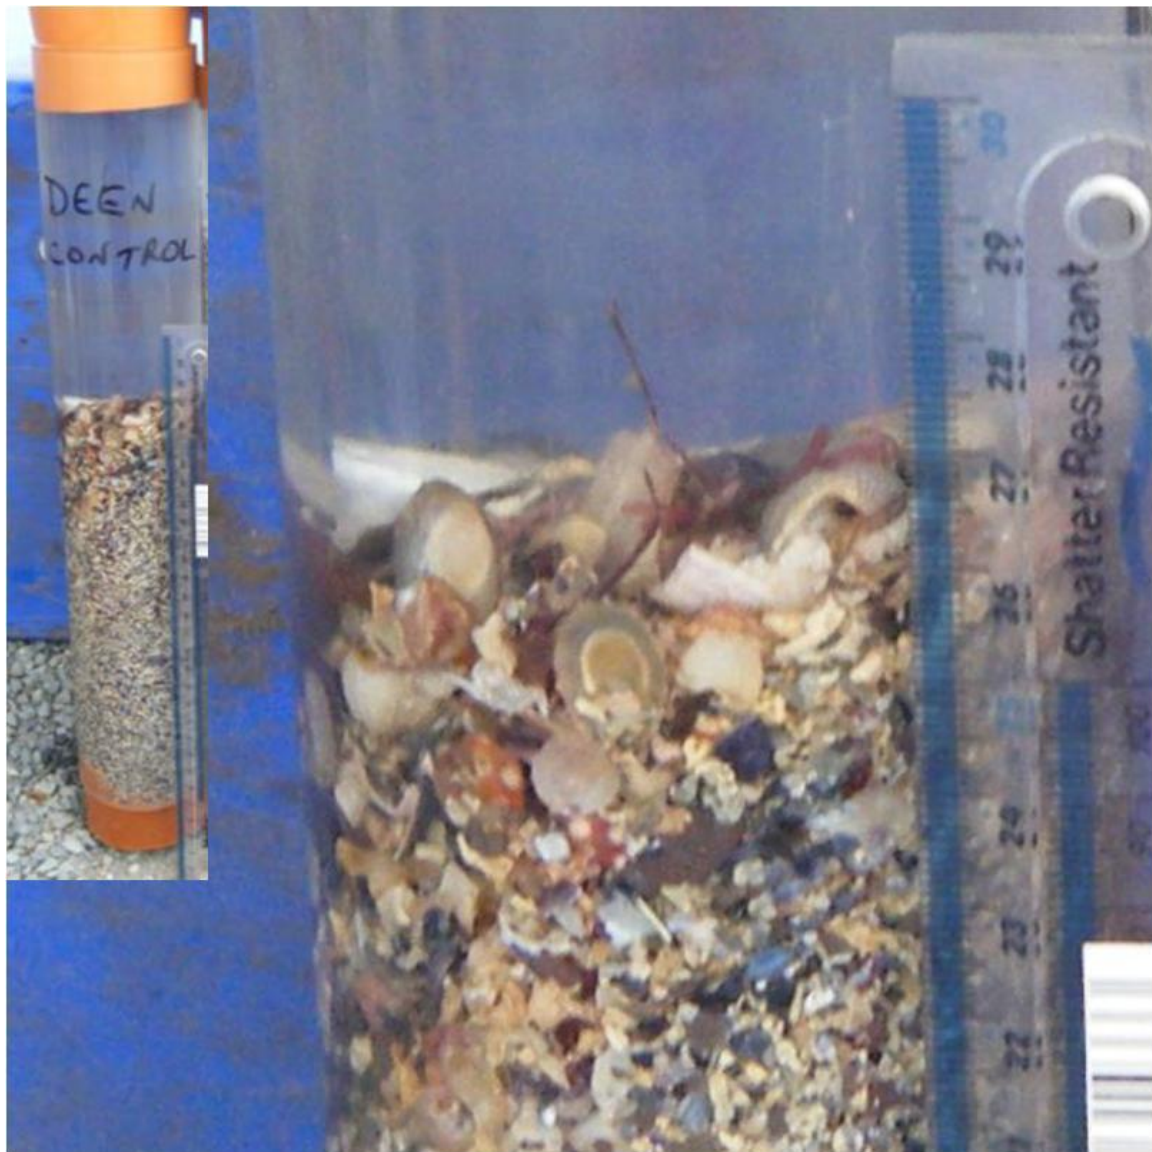
**Figure 5:** *Core sample from control station approximately 1km from Deenish fish farm site.*

Sediment at the control station (Figure 5) was a mix of coarse to very coarse sand, consisting of a high proportion of shell and small gravel. The lack of fine grains suggests that current speeds at the control are reasonably high, which reduces the likelihood of fine materials being able to settle out on to the bottom.

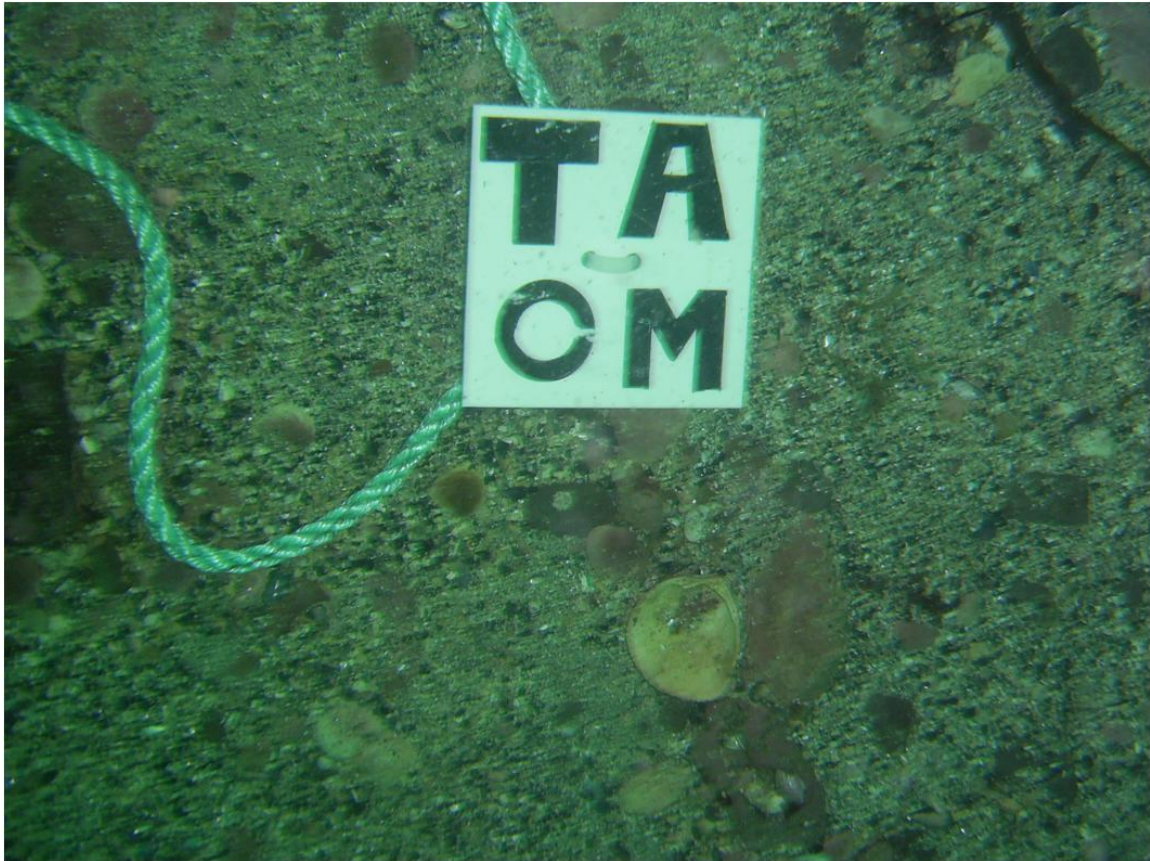
**Figure 7:** *Sediment at fish cages along Transect A at 0m from cage edge (Station TA0m) at Deenish fish farm site. Picture taken using underwater camera.*

Visibility was satisfactory. Figure 7 shows that the sediment was a mixture of coarse and very coarse sand, mixed with shell fragments. Whole shell halves can also be seen. There were no species discernable in the photograph. There was no evidence of waste feed and faecal material on the sediment surface.

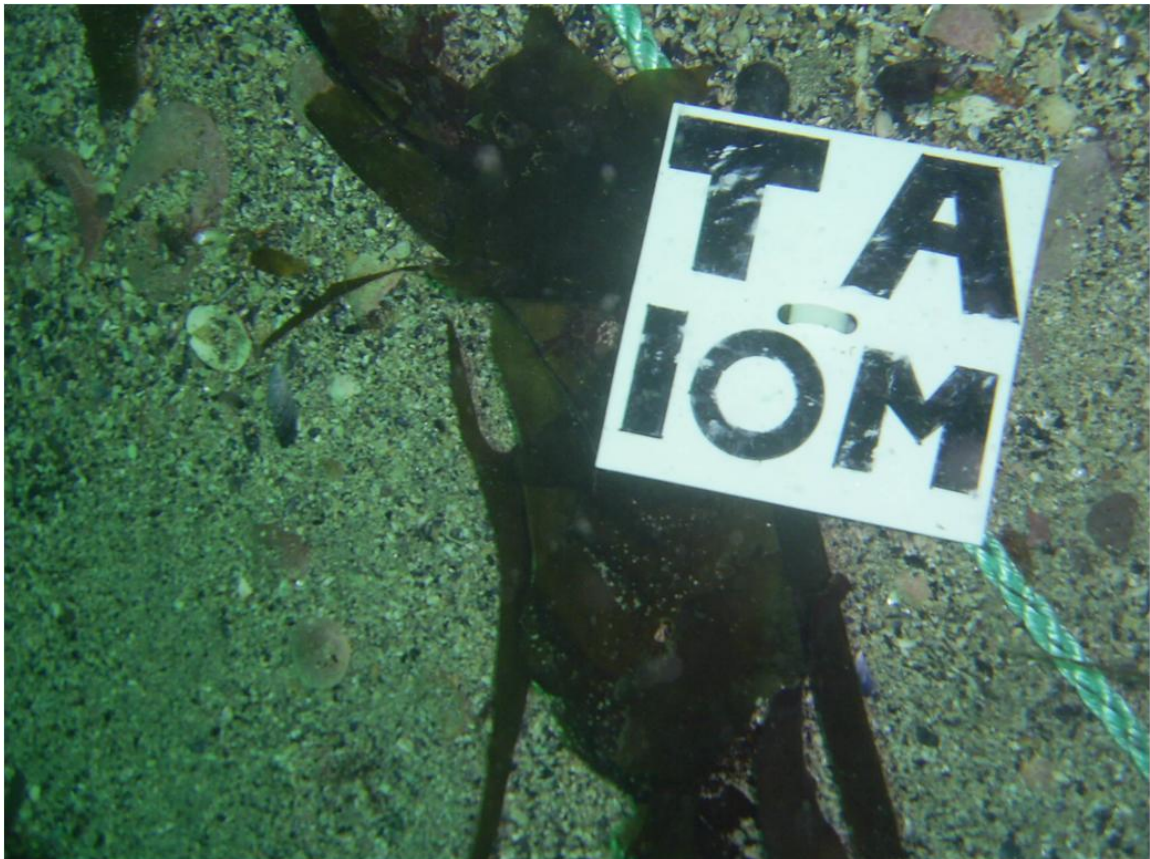
**Figure 8:** *Sediment at fish cages along Transect A at 10m from cage edge (Station TA10m) at Deenish fish farm site. Picture taken using underwater camera.*

Visibility was good. The surface sediment at TA10m (Figure 8) was coarse grained sand, mixed with occasional larger gravel and pebbles. Condition of the sediment seemed normal and no influence from the fish cages could be seen. Generally hard compacted there was little evidence of surface dwelling species.

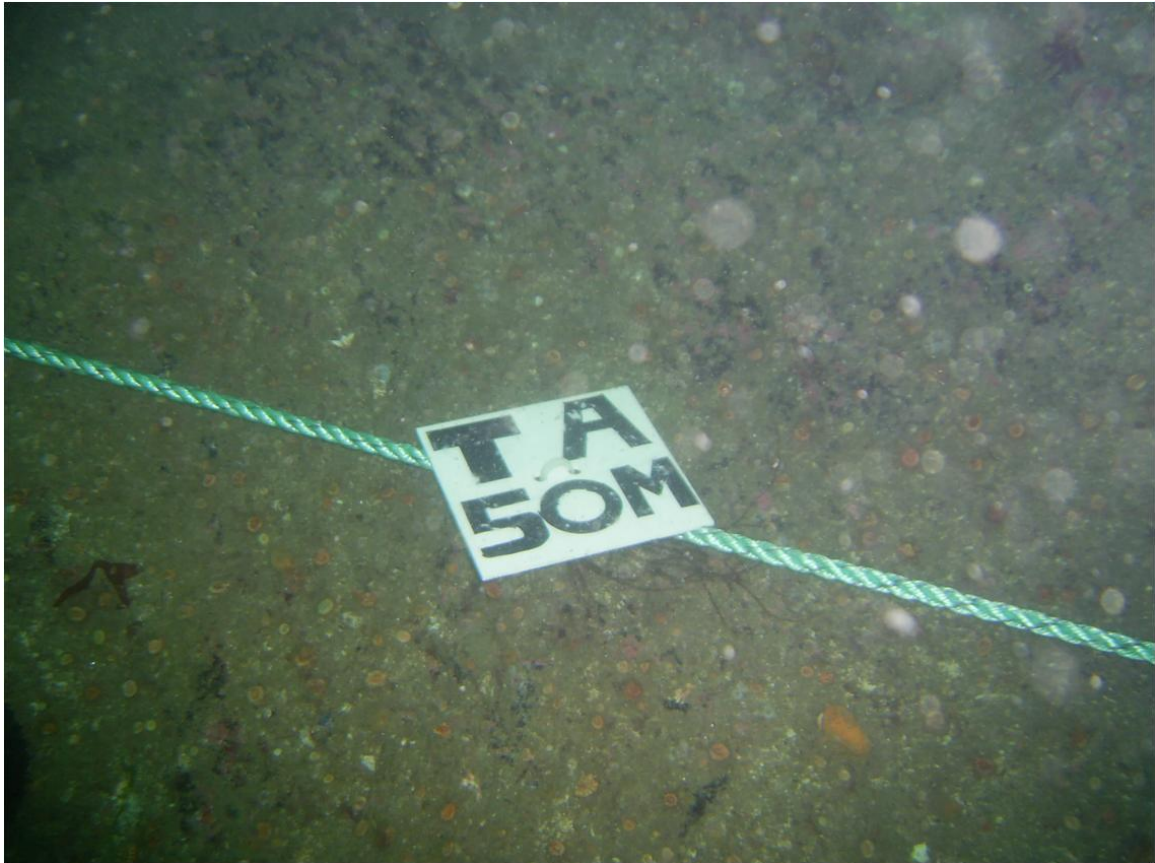
**Figure 10:** *Sediment at fish cages along Transect A at 50m from cage edge (Station TA50m) at Deenish fish farm site. Picture taken using underwater camera.*

Visibility was satisfactory to poor. The underlying surface at TA50m (Figure 10) was bedrock, which was covered in a layer of finer sediment. Settled over the whole area were what was thought to be Devonshire cup coral (*Caryophyllia* sp.)

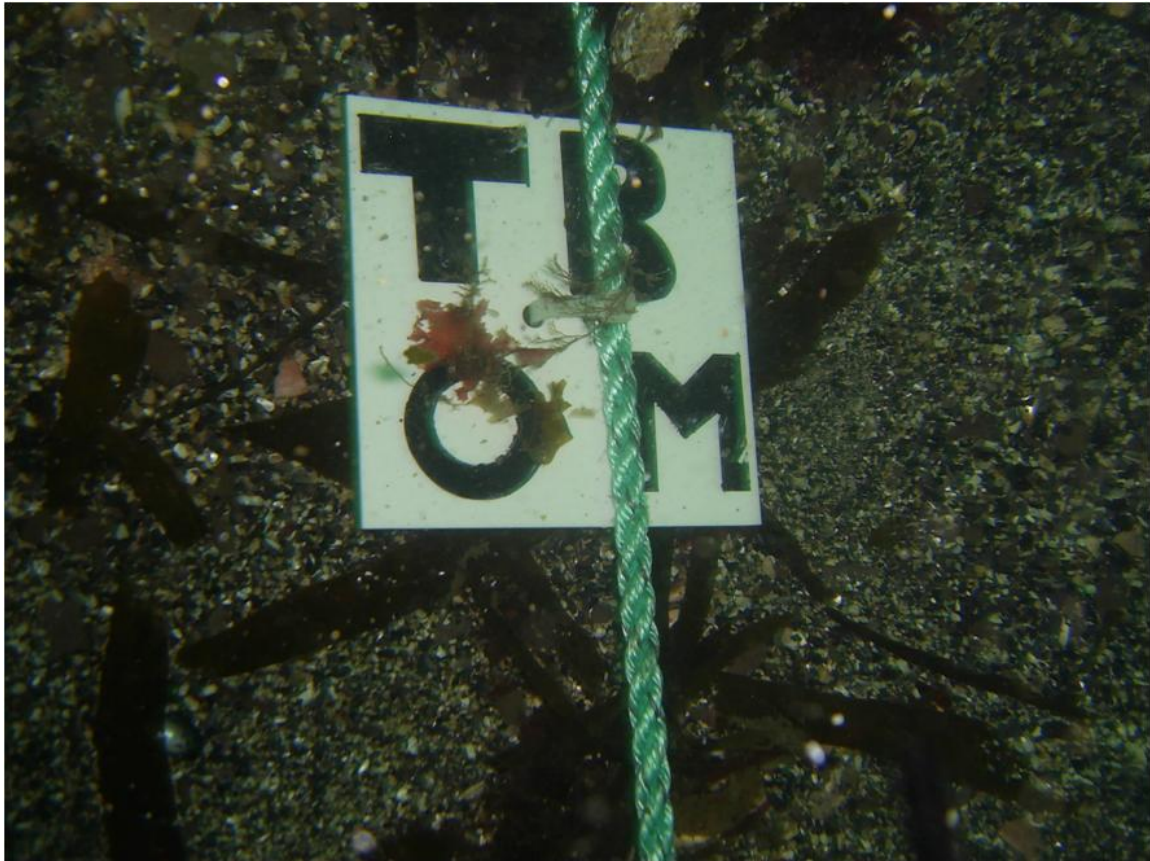
**Figure 12:** *Sediment at fish cages along Transect B at 0m from cage edge (Station TB0m) at Deenish fish farm site. Picture taken using underwater camera.*

Visibility was satisfactory. The sediments at the cage edge (TB0m) at Deenish (Figure 12) were of coarse and very coarse sand. Floating over the surface were detached frond of *Laminaria* sp. No other species were discernable. No feed and faecal pellets were visible on the sediment surface.

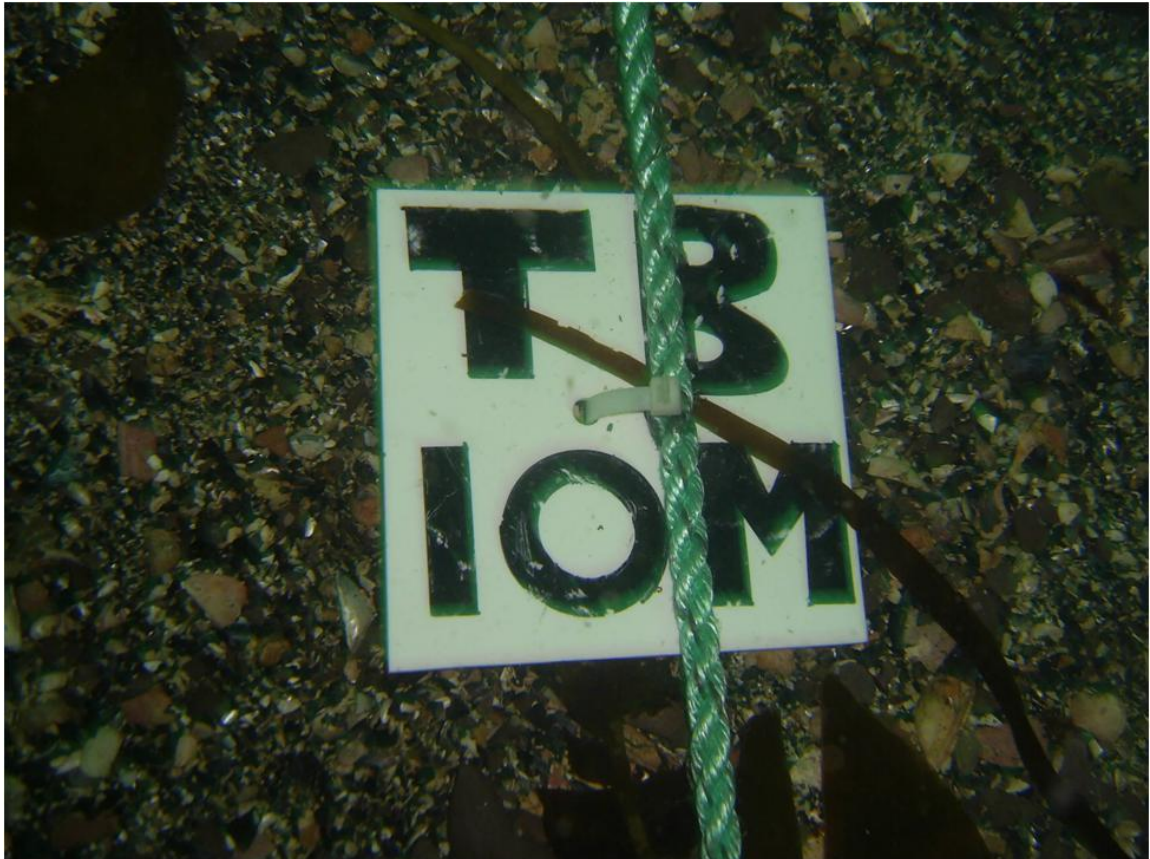
**Figure 13:** *Sediment at fish cages along Transect B at 10m from cage edge (Station TB10m) at Deenish fish farm site. Picture taken using underwater camera.*

Visibility was good. The sediments 10m from the cage edge (TB10m) (Figure 13) were very coarse sand, with gravel, pebbles and shell fragments of difference sizes. No feed and faecal material evident. No species were discernable.

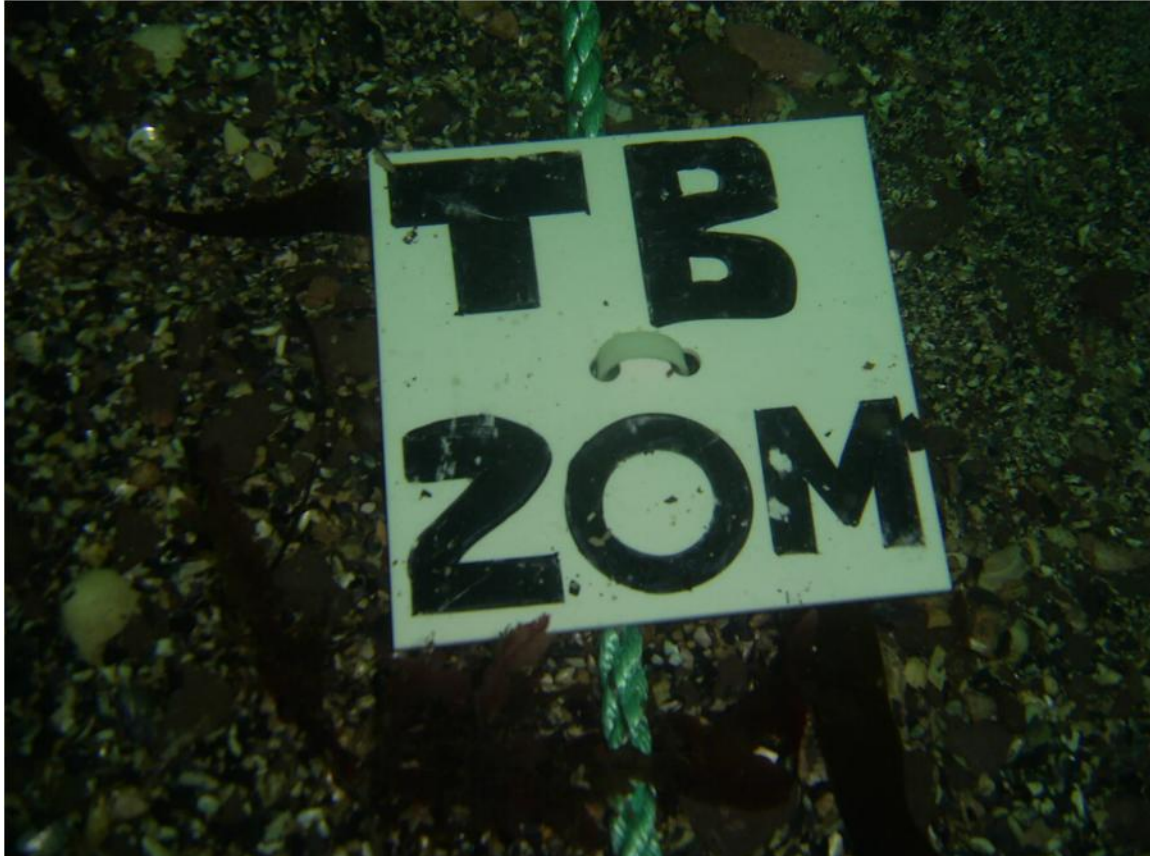
**Figure 14:** *Sediment at fish cages along Transect B at 20m from cage edge (Station TB20m) at Deenish fish farm site. Picture taken using underwater camera.*

Visibility was good. The sediments 20m from the cage edge (TB20m) at Deenish (Figure 14) were a mix of very coarse sand, gravel and shell fragments. No feed pellets were visible and no faecal materials were in evidence. No species were obviously discernable.

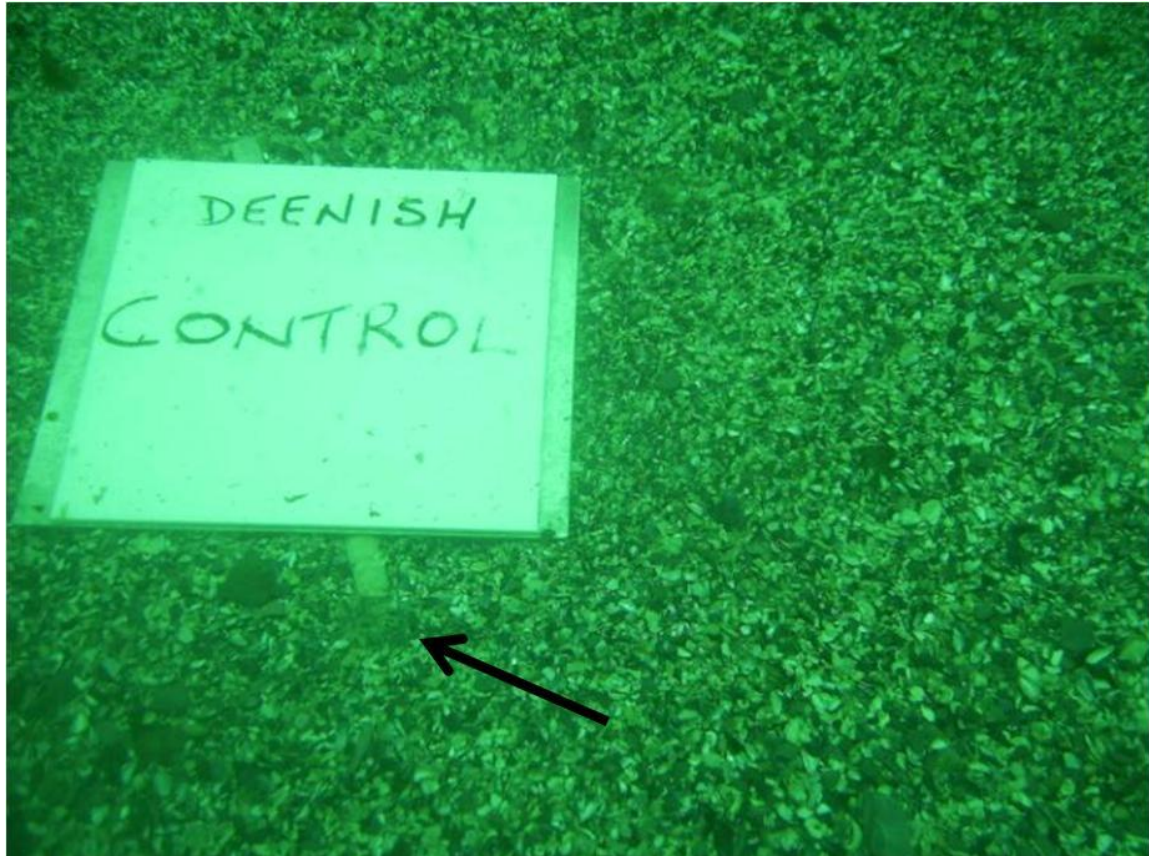
**Figure 16:** *Sediment at Deenish control site. Picture taken using hand held underwater camera.*

Sediment at the control site (Figure 16) was a mix of very coarse sand, with a high proportion of shell fragments. A single tube dwelling anemone (possibly *Cerianthus* sp.) was observed (arrowed). No other discernable species.
