Deenish 13S1 Stock Report

LICENCE REF. T6/202; AP1/2011
20.01.2015

MARINE HARVEST ASA

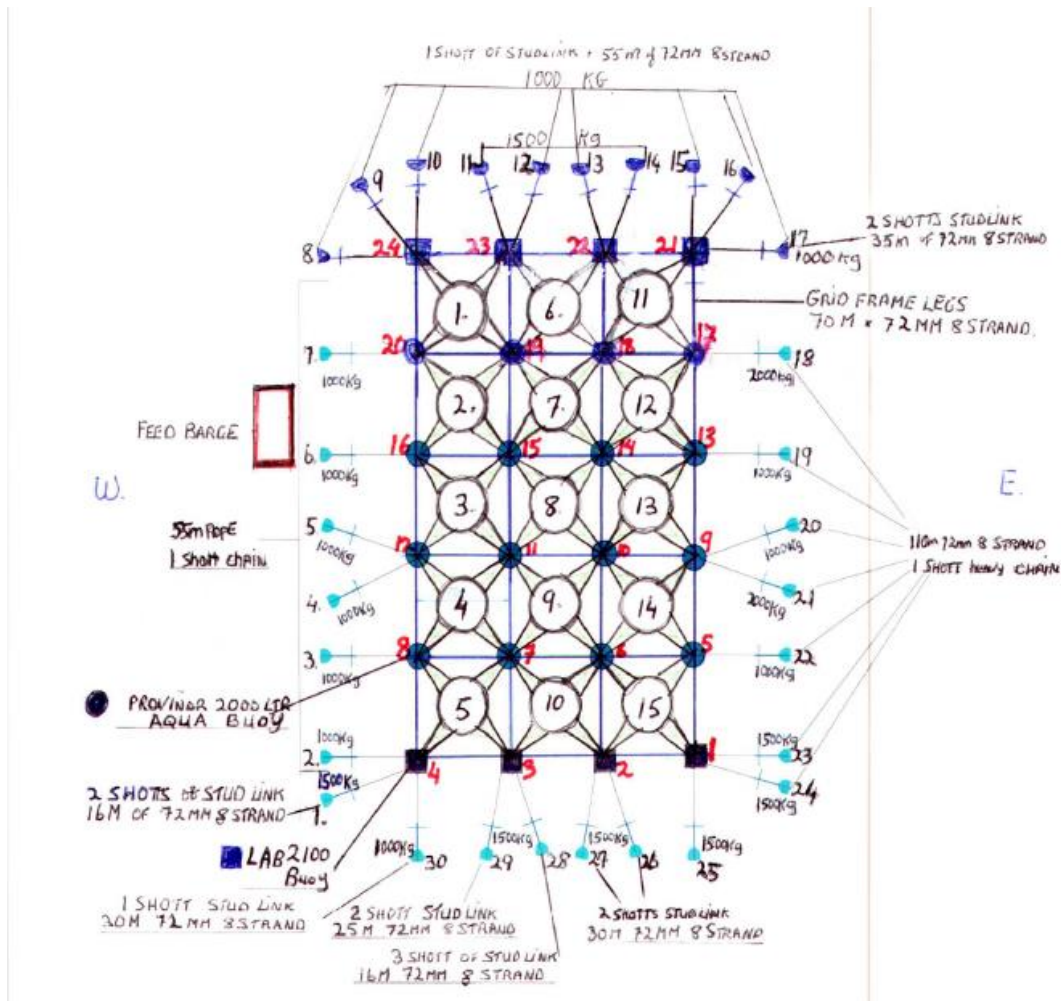
Figure 2
Site Staffing:

A total of 14 Aqualine plastic pens along with associated grid frame and moorings were laid out in a 3 x 5 grid pattern, within the licenced area. One pen was not stocked. A feed barge which also houses a small canteen and office was moored on the western site of the grid layout and in the lee of Deenish Island. Refer to the following sketch map. Fig. 2

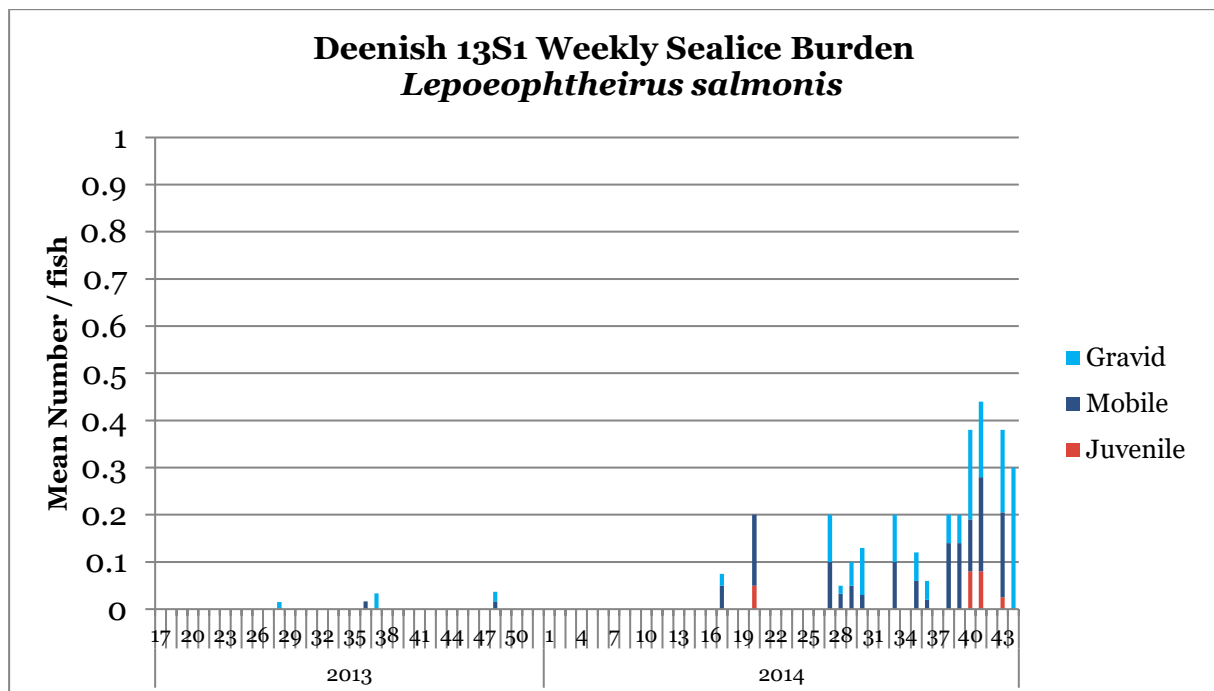
Fig. 3 Deenish Sea lice burden (all stages)

However, in the case of Deenish 13S1 crop, sea lice levels remained below treatment trigger levels and thus did not require any lice removal treatments. Sea lice levels for the 13S1 crop are summarised on the following graph.

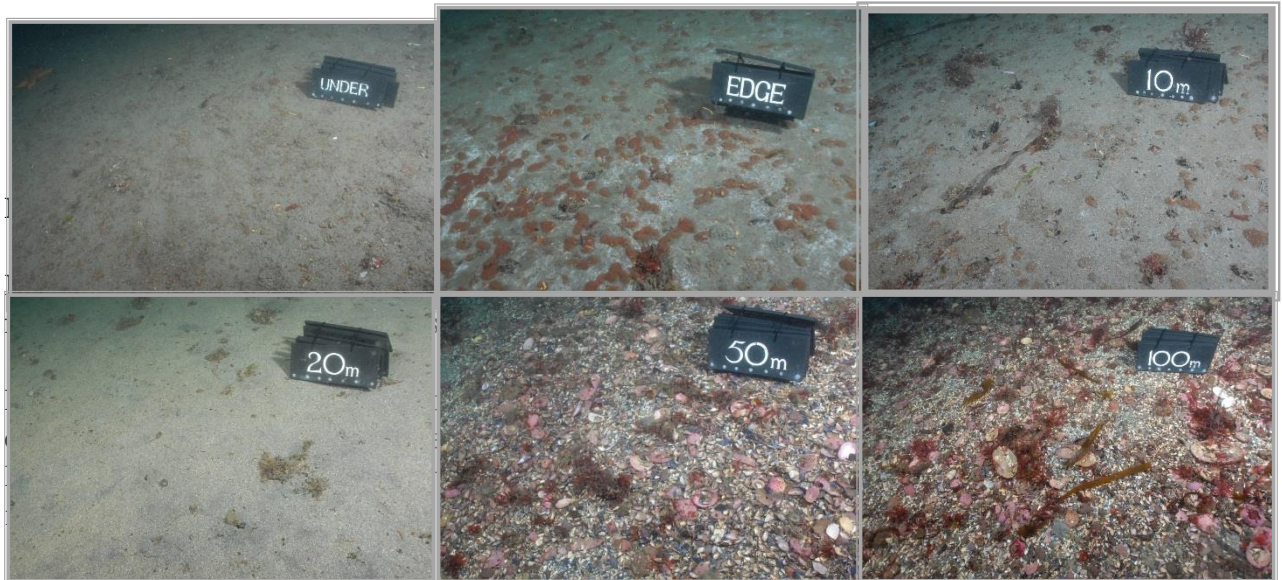
Figure 4: Sea bed images

The seabed was composed of a mix of sediment types with areas of of fine-medium sand and areas of slightly coarser sand shell gravel mix as can be seen in the following images.

The composition of sediments at each station can be seen in the sediment profile imagery (SPI) images with fine sand at the under pen station to a coarser shelly gravelly sand at the outer end of the transect. (Fig. 4). ARPD depths ranged from a minimum of 0.2cm (T1 Under, T1 Edge, T1 20m and T1 50m) to a maximum of >6.5cm (T1 100m). (Fig. 5).
